APPENDIX B

COMMUNITIES

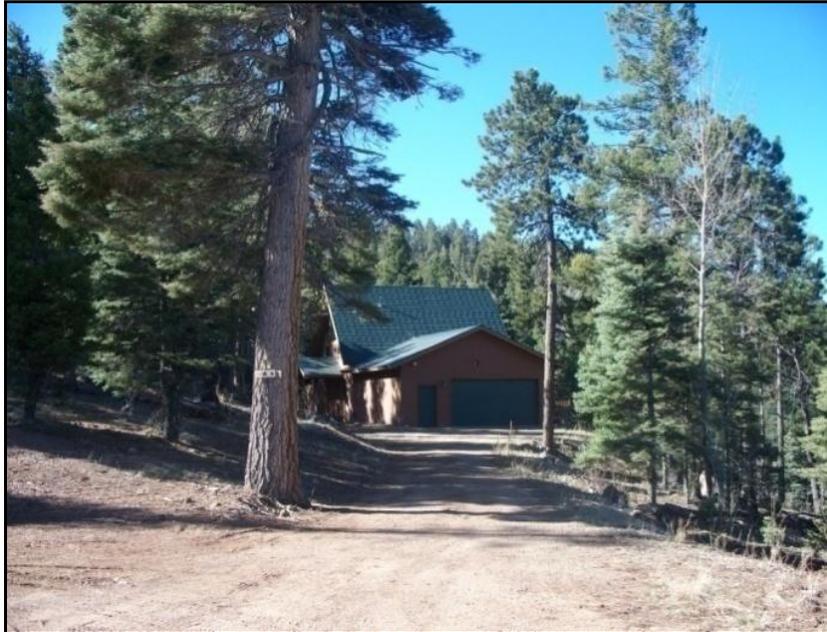
1. *Vail Loop* – Hazard Rating Very High

Vail Loop is a community that has similar infrastructure to most of the communities within the Angel Fire Village. Residences are located on lots over an acre in size. Although the homes have roofs that are highly resistant to fire, the siding is a mixture of combustible and non-combustible materials. There are open areas under decks where wood is stored and fire could potentially threaten the house. Steep slopes, ravines and chimneys are topographical features that are prominent throughout. Many of the structures are located in drainages that contain thick fuels. Not all of the houses have defensible space, but there are some that have exceptionally well done mitigation work. Some of the driveways are extremely (>30%) steep and inaccessible. Addressing is inconsistent, and many of the houses lack reflective addressing. The roads are well maintained gravel, and are generally greater than 20 feet wide. There are adequate turnarounds and hydrants are located throughout the neighborhood.

The dominant tree species in the area is Douglas fir. Pure, dense stands of fir are most common, but various other species are also located within the community, including white fir, and aspen. There is an exceptional variety in the fuels, including a west facing slope with Gambel oak and piñon pines. Although surface fire is likely under moderate weather conditions, torching is possible, especially along the Vail Overlook road and in the west facing slopes and drainages below the community on the west side. Low rates of spread are expected. Extreme weather conditions would promote tree torching, especially on the west facing slope that leads up from the highway. The steep slopes promote preheating and continued burning. Long flame lengths and increased rates of spread are probable, especially up south facing slopes where fuels are typically drier and more susceptible to fire spread.

- Improve road signs so they are non-combustible, 4" and reflective.
- Adequate defensible space is recommended for all homes.
 - Simply mowing or weed whacking for 50 feet around homes and structures, and cleaning leaf and needle litter from roofs and gutters and away from foundations, will profoundly increase structure survivability.

- Discourage the use of combustible materials for the construction of projections below roof line such as decks.
- Open areas below decks and projections should be enclosed or screened to prevent the ingress of embers and kept clean of flammable materials, especially where such openings are located on slopes above fuels. Use fine mesh metal screen (1/4" or less) to cover eaves, roof, and foundation vents.

- Discourage the planting of flammable ornamental vegetation within 30 feet of homes.
- Replace plastic address markers, using reflective, non-combustible materials. A good guideline for this practice is to place the markers five feet above ground level on the right side of the driveway.

- Extended defensible space is recommended for most homes, due to the dangerous topography and heavy fuel loads in and adjacent to this community.
- Remove wood piles and any flammable yard clutter to at least 30 feet from structures and propane tanks. Wood piles should be located uphill or even with homes; never downhill.

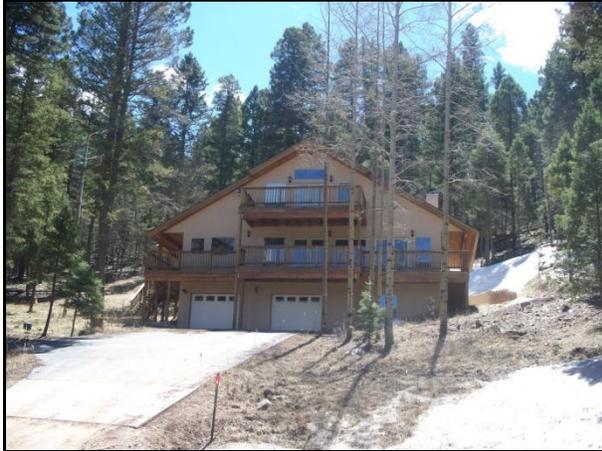
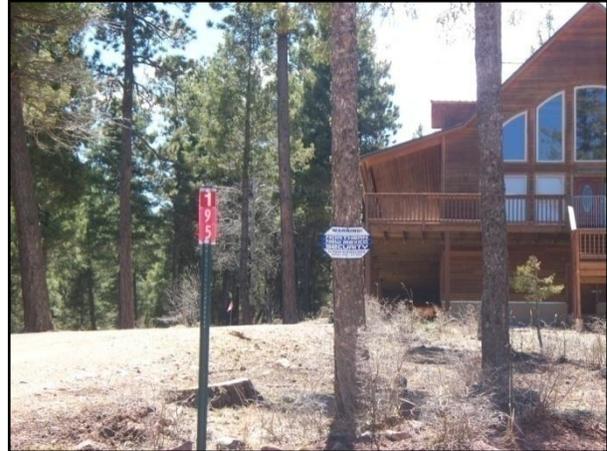
2. Back Basin – Hazard Rating Very High

Back Basin is a community that borders the ski area and has low housing density. Most of the homes are located off of Back Basin Road and are on steep slopes. The lots are over an acre and are undeveloped, but lots with houses have metal roofs that have high fire resistance and mixture of combustible and non-combustible siding. Addressing is consistent with reflective plastic markers mounted on metal rods. Defensible space has been completed around some residences and as a function of clearing the land to build the houses. The utilities are all underground. There is only one way in and out via Back Basin Road, which is long and windy. Roads are generally wider than 20 feet and have adequate clearance and turnarounds. While the road slope is generally under 10%, there are a few sections that approach this grade. The street signs are wooden and non-reflective. There are hydrants located along the Back Basin Road.

- Improve road signs so they are non-combustible, 4" and reflective
- Adequate defensible space is recommended for all homes.
 - Simply mowing or weed whacking for 50 feet around homes and structures, and cleaning leaf and needle litter from roofs and gutters and away from foundations, will profoundly increase structure survivability.

- Discourage the use of combustible materials for the construction of projections below roof line such as decks.
- Open areas below decks and projections should be enclosed or screened to prevent the ingress of embers and kept clean of flammable materials, especially where such openings are located on slopes above fuels. Use fine mesh metal screen (1/4" or less) to cover eaves, roof, and foundation vents.

- Discourage the planting of flammable ornamental vegetation within 30 feet of homes.
- Replace plastic address markers, using reflective, non-combustible materials. A good guideline for this practice is to place the markers five feet above ground level on the right side of the driveway.

- Extended defensible space is recommended for most homes, due to the dangerous topography and heavy fuel loads in and adjacent to this community.
- Remove wood piles and any flammable yard clutter to at least 30 feet from structures and propane tanks. Wood piles should be located uphill or even with homes; never downhill.

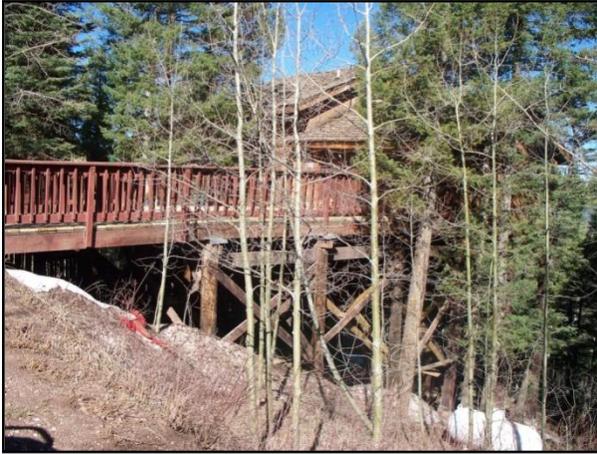
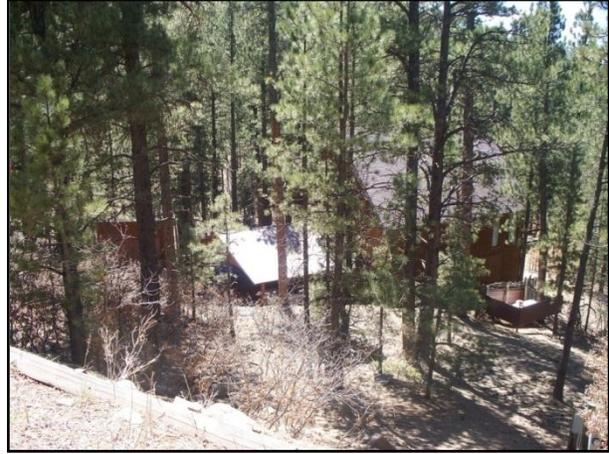
3. *El Camino Real* – Hazard Rating Very High

El Camino Real is similar to many of the other communities in Angel Fire Village. Some houses have non-combustible siding, while others have combustible wood siding and decks. All of the structures have non-combustible roofs, which are a requirement of the Village. The lots are generally larger than an acre, but many are vacant and have over-grown vegetation. Some homeowners have created defensible space around their property, but not all of the residents have yet to complete mitigation work. The utilities are located underground. There are multiple routes of ingress/egress along well maintained gravel roads, but often the roads can be confusing and travel is likely to be slowed if there were a wildfire. Although the road grades are less than 10%, many of the driveways are much steeper and access by emergency equipment is limited. Road signs are non-combustible, but not reflective, making them difficult to read at night. There are hydrants available throughout the community, as well as several water municipal water tanks, holding more than 50,000 gallons each.

The dominant fuel type throughout the community is mixed conifer. The majority of the trees are Douglas firs and some bristlecone pine. The canopy and the understory both have heavy amounts of fuel loading. At higher elevations, subalpine fir and Engelmann spruce are the dominant species. Moderate weather conditions will support surface fire, and some individual tree torching. Low rates of spread and flame lengths would be common. However, extreme weather conditions are capable of moving fire from the surface into the canopies. Large-scale tree torching is likely, especially along the main roads like Cheerful Overlook, El Camino Real, Panorama Way, and Skyview Lane. This issue is intensified on the south facing slopes and rates of spread could be upwards of ½ mile (40 chains) per hour. Flame lengths would likely be longer than 12 feet, inhibiting use of ground crews. If a fire were to start along Mountain View Boulevard, the fuels to the west of El Camino Real would be preheated, and crown fire would spread up the west facing aspect. Dense fuels on the south border of the community could also carry fire quickly up through the tops of the trees and carry fire quickly uphill towards homes located on the top of the peak.

- Mark evacuation routes with reflective signage.
- Improve road signs so they are 4" and reflective.
- Adequate defensible space is recommended for all homes.

- Simply mowing or weed whacking for 50 feet around homes and structures, and cleaning leaf and needle litter from roofs and gutters and away from foundations, will profoundly increase structure survivability.

- Discourage the use of combustible materials for the construction of projections below roof line such as decks.
- Open areas below decks and projections should be enclosed or screened to prevent the ingress of embers and kept clean of flammable materials, especially where such openings are located on slopes above fuels. Use fine mesh metal screen (1/4" or less) to cover eaves, roof, and foundation vents.

- Discourage the planting of flammable ornamental vegetation within 30 feet of homes.
- Replace plastic address markers, using reflective, non-combustible materials. A good guideline for this practice is to place the markers five feet above ground level on the right side of the driveway.

- Extended defensible space is recommended for most homes, due to the dangerous topography and heavy fuel loads in and adjacent to this community.
- Remove wood piles and any flammable yard clutter to at least 30 feet from structures and propane tanks. Wood piles should be located uphill or even with homes; never downhill.

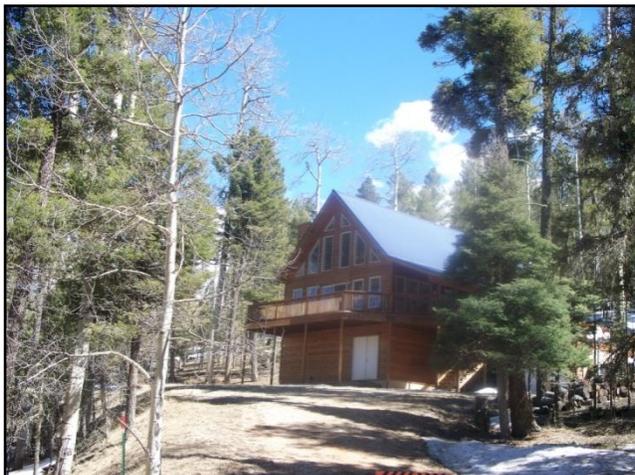
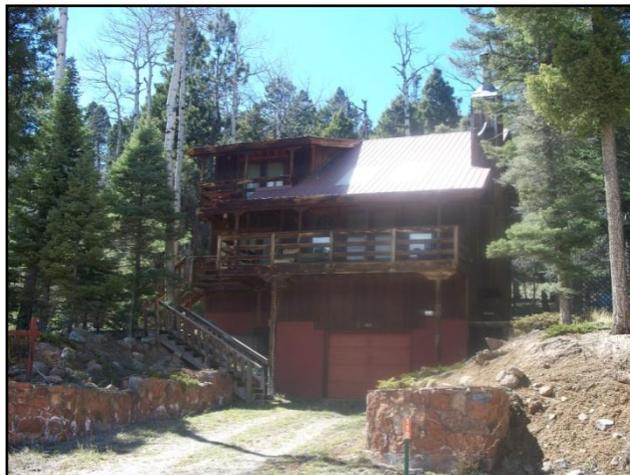
4. Taos Drive – Hazard Rating High

Taos Drive is located at the south end of the Village. The homes are similar to many of the others on the west side of the Village, in that the roofs are metal, and highly resistant to fire, and there is a mixture of combustible and non-combustible siding and decks. While some defensible space mitigation has been completed, most homes do not have any defensible space. The lots are typically under an acre in size. All of the utilities are located underground. Addressing is variable; some houses have reflective markers along the driveways, while others are unmarked or difficult to read. Unlike most of the other communities, Taos Drive has a higher number of year-round residences. Wood storage is an issue, since many people are storing wood against the structures and on decks. The Taos Drive community has a single gravel road for ingress/egress along Taos Drive and has multiple dead ends that are unmarked, which could present serious problems during an evacuation. The roads within the community are generally 24 feet wide and are gravel. There are adequate turnarounds throughout. Street signs are present, but are combustible and non reflective. Hydrants are present, but they are sparsely located.

Like many of the communities, the fuels within the Taos Drive community are extremely dense. Both ponderosa pines and Douglas firs are dominant tree species. Aspen are mixed within the mixed conifers. There is not a large quantity of surface fuels. Although most of the community has slopes less than 15%, there are drainages and areas greater than 30%. With moderate weather conditions, surface fire is most likely throughout the entire community, regardless of fuels or slope. Flame lengths would be less than four feet. Rate of spread is expected to be less than ¼ mile per hour. Extreme weather may cause torching along the south end of the community, especially on the south and east facing slopes. Rate of spread is not expected to be very fast. Fire spread from tree to tree is not likely because the lack of ladder fuels to bring the fire into the crowns with moderate conditions. However, higher speed winds could create flame lengths that are long enough to extend into the crowns and cause small areas of torching and flying embers.

- Replace plastic address markers with reflective metal signs.
- Make sure all dead ends are marked as such.
- Adequate defensible space is recommended for all homes.

- Simply mowing or weed whacking for 50 feet around homes and structures, and cleaning leaf and needle litter from roofs and gutters and away from foundations, will profoundly increase structure survivability.

- Discourage the use of combustible materials for the construction of projections below roof line such as decks.
- Open areas below decks and projections should be enclosed or screened to prevent the ingress of embers and kept clean of flammable materials, especially where such openings are located on slopes above fuels. Use fine mesh metal screen (1/4" or less) to cover eaves, roof, and foundation vents.

- Discourage the planting of flammable ornamental vegetation within 30 feet of homes.
- Replace plastic address markers, using reflective, non-combustible materials. A good guideline for this practice is to place the markers five feet above ground level on the right side of the driveway.

- Extended defensible space is recommended for most homes, due to the dangerous topography and heavy fuel loads in and adjacent to this community.
- Remove wood piles and any flammable yard clutter to at least 30 feet from structures and propane tanks. Wood piles should be located uphill or even with homes; never downhill.

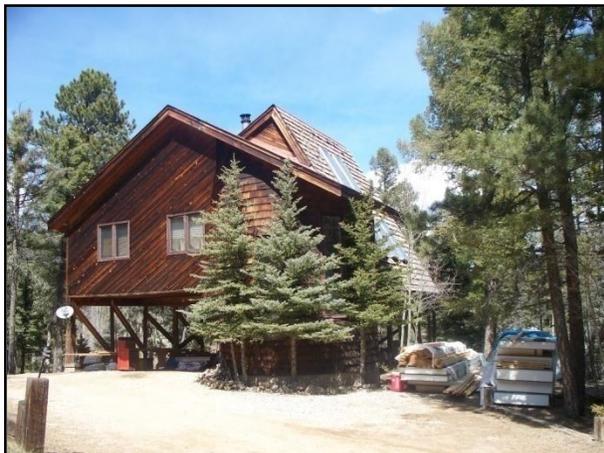
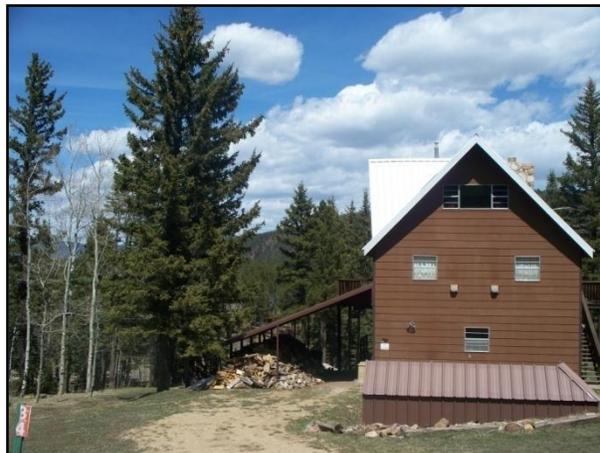
5. South Village – Hazard Rating High

The South Village community is similar to the Taos Drive community in terms of housing density and infrastructure. Lot sizes are less than an acre, and houses are relatively dense. There are undeveloped lots within this community as well, in addition to a non year-round population. Almost all of the houses have metal roofs, but there are a few that still have cedar shake roofs and combustible siding. Wood is frequently stored against houses. The majority of the homes have reflective plastic signs, but the plastic is often broken. Some homes have defensible space, but the majority are lacking any mitigation. Houses that are located around Monte Verde Lake are located in a more open area. There are multiple ways in and out of the community along a series of maintained gravel roads. However, the road network leading into the community from Lakeview Park Drive is extremely confusing. The road names include Lake Park Drive, Lakewood Park Terrace, Lakeview Circle, and Lakeview Park. Because the road signs are inconsistent, it is often difficult to determine which road is which. Road widths and turnarounds allow for emergency equipment access. Hydrants are present, but are not found with as high of frequency as some other places in the Village.

Around the lake, grass and ponderosa pine are the dominant fuels. There is little regeneration in the understory, so as a result, few ladder fuels. In the transition from the open grasslands to the forest, there is a large aspen component. On the slopes, mixed conifer, including ponderosa pine and Douglas fir become more dominant. Pockets of aspen are present throughout. There is not a large threat of fire in the tree crowns under moderate weather conditions. There are not enough ladder fuels or strong enough wind to allow fire to spread into the crowns. Rates of spread would likely be slower than a quarter mile per hour. Higher wind speeds are capable of carrying the fire into the trees and torching groups of trees. Longer flame lengths could produce embers that could spread fire to the houses within the community.

- Adequate defensible space is recommended for all homes.
 - Simply mowing or weed whacking for 50 feet around homes and structures, and cleaning leaf and needle litter from roofs and gutters and away from foundations, will profoundly increase structure survivability.

- Discourage the use of combustible materials for the construction of projections below roof line such as decks.
- Open areas below decks and projections should be enclosed or screened to prevent the ingress of embers and kept clean of flammable materials, especially where such openings are located on slopes above fuels. Use fine mesh metal screen (1/4" or less) to cover eaves, roof, and foundation vents.

- Discourage the planting of flammable ornamental vegetation within 30 feet of homes.
- Replace plastic address markers, using reflective, non-combustible materials. A good guideline for this practice is to place the markers five feet above ground level on the right side of the driveway.

- Remove wood piles and any flammable yard clutter to at least 30 feet from structures and propane tanks. Wood piles should be located uphill or even with homes; never downhill.

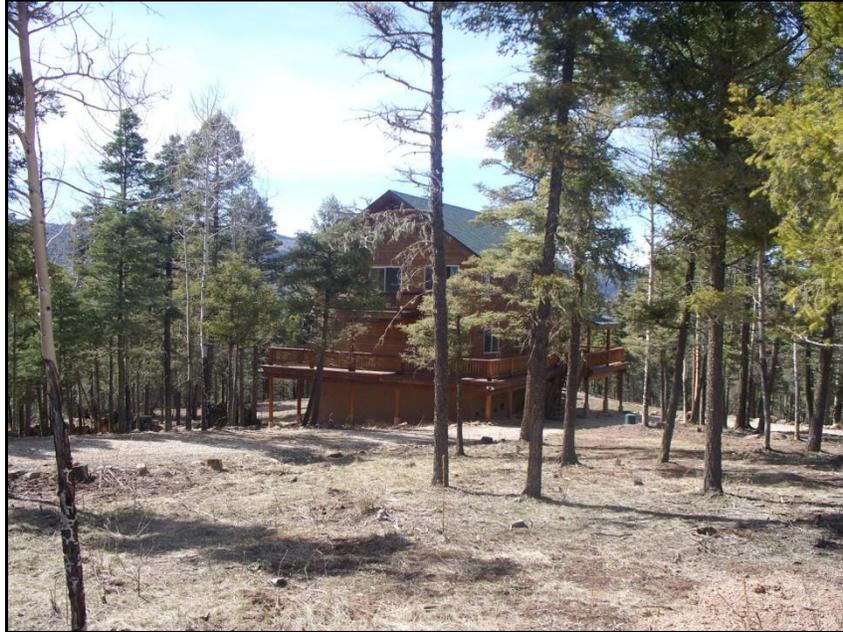
6. South East Village – Hazard Rating High

The South East Village is similar to the South Village, but is on the opposite side of Mountain View Boulevard. As a result, the aspect is west facing instead of east facing. Houses are located on lots less than an acre in size. The deck and siding is a mixture of both combustible and non-combustible materials. Roofs are metal and highly resistant to fire. There is a large component of non year-round residents. Wood storage is often against structures and trees located on the property. The addressing is inconsistent and needs improving. Some of the houses have defensible space, but not all. The presence of vacant lots which have had no mitigation work completed poses a threat to the adjacent developed lots. There is new construction occurring throughout, and all new building should adhere to the Wildland Urban Interface Code. All of the utilities are located underground. There is only one way in and out of the community, but the close proximity of the highway shortens evacuation times. Roads are good gravel and provide adequate turnarounds for apparatus. Street signs are often not present, and those that are, are not reflective and fashioned from combustible materials. Hydrants are scattered through the community.

Mixed conifer stands are the dominant species at the lower elevations and on the sides of the drainages. Aspen are present in the drainages due to the high amount of available water. Ponderosa pine is also present and dense stands of ponderosa exist with Douglas fir in the understory. There is continuous crown cover, but rather low surface loading. There is a significant component of small trees in the understory. Under moderate weather conditions, crown fire is not expected; surface fires would be most likely. However, given the prevailing south west winds and the steep slopes that lead from Mountain View Boulevard, more active fire behavior could be possible. Small groups of trees torching can preheat trees further up the hill and allow for an uphill fire run.

- Ensure evacuation routes are marked with reflective signage.
- Improve road signs so they are 4" and reflective.
- Adequate defensible space is recommended for all homes.

- Simply mowing or weed whacking for 50 feet around homes and structures, and cleaning leaf and needle litter from roofs and gutters and away from foundations, will profoundly increase structure survivability.

- Discourage the use of combustible materials for the construction of projections below roof line such as decks.
- Open areas below decks and projections should be enclosed or screened to prevent the ingress of embers and kept clean of flammable materials, especially where such openings are located on slopes above fuels. Use fine mesh metal screen (1/4" or less) to cover eaves, roof, and foundation vents.

- Discourage the planting of flammable ornamental vegetation within 30 feet of homes.
- Replace plastic address markers, using reflective, non-combustible materials. A good guideline for this practice is to place the markers five feet above ground level on the right side of the driveway.

- Remove wood piles and any flammable yard clutter to at least 30 feet from structures and propane tanks. Wood piles should be located uphill or even with homes; never downhill.

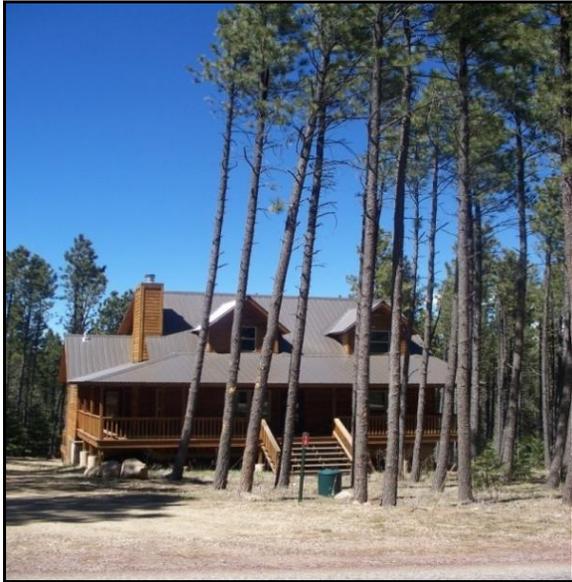
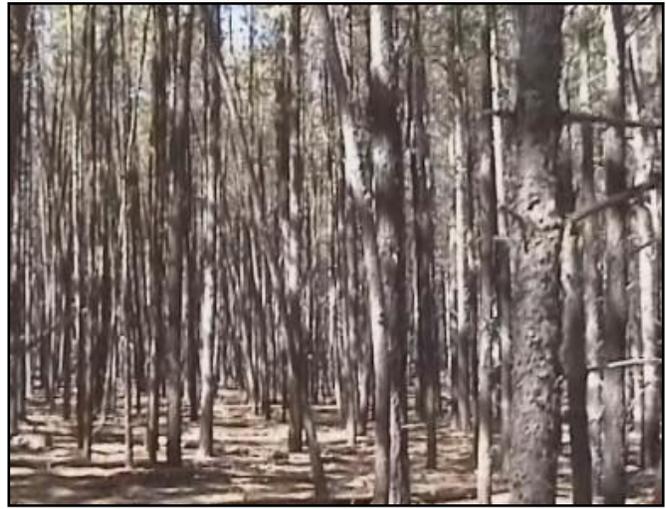
7. Valle Grande North – Hazard Rating High

Houses in this area are located on lots that are less than an acre in size. Some of the residences are built mid-slope, aligned with small, steep ravines. There are many undeveloped lots throughout the community. The existing residences are comprised of metal roofs, which are highly resistant to fire, but they typically have combustible siding. Needle build-up on roofs is common. Little defensible space work has been done around many of the structures. A large percentage of the homes are not occupied year-round. Wood storage is often under or on decks, and right against the homes. The utilities are all located underground. Home addressing is inconsistent; not every house has reflective plastic signage, and some that do are broken due to snow damage. The south section of the community does not currently have any infrastructure. The land has been marked into individual lots, but no building has been occurring yet. Underground utilities, including power, phone, and sewer lines will be underground. Any building will be required to have a metal roof and defensible space. There are multiple routes of ingress/egress within the community along paved and gravel roads. Many roads within the community are dead ends, but are not marked. Street signs are either not present or if present, are neither fire resistant nor reflective. Hydrants are present, but are sparsely located. Green belt trails are located throughout, which encourage use by residents.

The vegetation in the community is extremely dense. Ponderosa pines are the dominant species and are growing in what is known as 'dog-hair' stands. There are a few Douglas fir trees that are beginning to grow in the understory, but overall, little light penetrates the canopy. As a result, the understory is comprised of little surface vegetation, mainly needle-cast. The area of the community west of Via del Rey has lower density trees and an oak understory. The south facing slopes have drier fuels that are predisposed to fire. Moderate weather conditions include lower wind speeds, which are not capable of carrying fire into the tree canopies. Higher speed winds are more likely to create longer flame lengths that can extend into the crowns. As a result, clumps of trees are likely to torch. The extended flame lengths from the torching can heat fuels further uphill, and allow active crown fire to spread uphill. North facing slopes are typically more moist, and do not have the propensity to burn.

- Improve road signs so they are non-combustible, 4" and reflective.
- Make sure all dead ends are marked as such.
- Adequate defensible space is recommended for all homes.

- Simply mowing or weed whacking for 50 feet around homes and structures, and cleaning leaf and needle litter from roofs and gutters and away from foundations, will profoundly increase structure survivability.

- Discourage the use of combustible materials for the construction of projections below roof line such as decks.
- Open areas below decks and projections should be enclosed or screened to prevent the ingress of embers and kept clean of flammable materials, especially where such openings are located on slopes above fuels. Use fine mesh metal screen (1/4" or less) to cover eaves, roof, and foundation vents.

- Discourage the planting of flammable ornamental vegetation within 30 feet of homes.
- Replace plastic address markers, using reflective, non-combustible materials. A good guideline for this practice is to place the markers five feet above ground level on the right side of the driveway.

- Remove wood piles and any flammable yard clutter to at least 30 feet from structures and propane tanks. Wood piles should be located uphill or even with homes; never downhill.

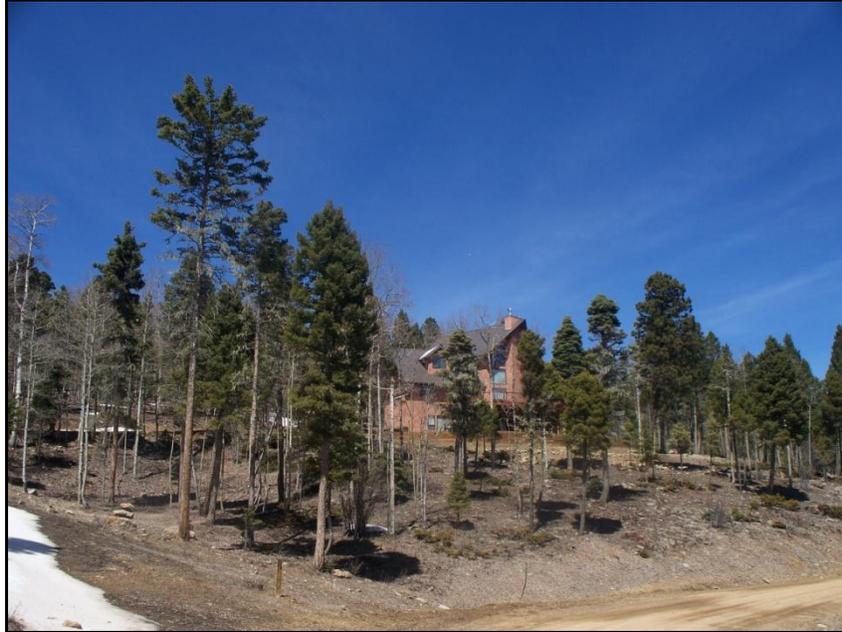
8. *The Aspens* – Hazard Rating Moderate

The Aspens community spans the west side of Angel Fire Village and borders the Carson National Forest. There are only a few homes in the community, and many vacant lots that have yet to be developed. Many of the homeowners do not live here year-round. The existing residences have metal roofs, and generally a mixture of combustible and non-combustible siding and decks. The majority of the homes do not have any defensible space. Many new, large, timber homes are being built along Via de Maria. Utilities are all located underground. Home addressing is mixed, and it is often not reflective or visible from the driveways. Several of the driveways are long and steep. Road widths are wide and provide adequate turnarounds; however, road signs are not reflective and are made out of combustible materials. There are multiple ways in and out of The Aspens, but the routes are long and could become confusing if a wildfire were to occur. Hydrants are located every 300 feet. There is also a 200,000 gallon water tank located within the community.

- Improve road signs so they are non-combustible, 4" and reflective.
- Mark escape routes so they are clearly visible.
- Adequate defensible space is recommended for all homes.

- Simply mowing or weed whacking for 50 feet around homes and structures, and cleaning leaf and needle litter from roofs and gutters and away from foundations, will profoundly increase structure survivability.

- Discourage the use of combustible materials for the construction of projections below roof line such as decks.
- Open areas below decks and projections should be enclosed or screened to prevent the ingress of embers and kept clean of flammable materials, especially where such openings are located on slopes above fuels. Use fine mesh metal screen (1/4" or less) to cover eaves, roof, and foundation vents.

- Discourage the planting of flammable ornamental vegetation within 30 feet of homes.
- Replace plastic address markers, using reflective, non-combustible materials. A good guideline for this practice is to place the markers five feet above ground level on the right side of the driveway.

- Extended defensible space is recommended for most homes, due to the dangerous topography and heavy fuel loads in and adjacent to this community.
- Remove wood piles and any flammable yard clutter to at least 30 feet from structures and propane tanks. Wood piles should be located uphill or even with homes; never downhill.

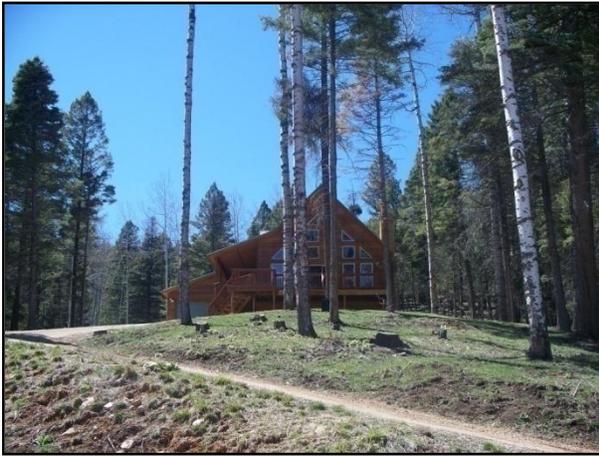
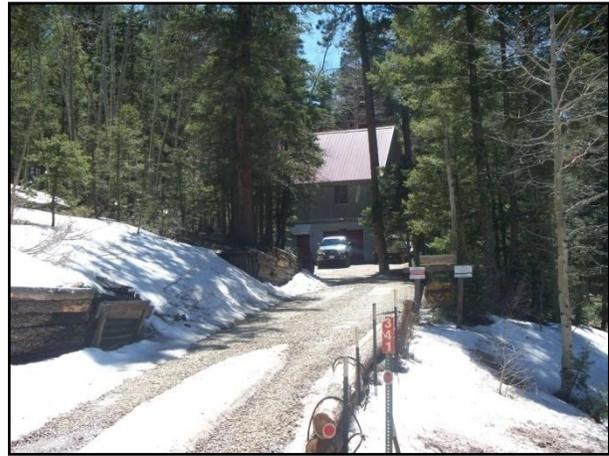
9. North Via del Rey – Hazard Rating Moderate

North Via del Rey is located downhill of The Aspens community. The community sits above the golf course, which acts as a partial fuelbreak from potential ignitions from Mountain View Boulevard. There are a lot of empty lots located within the community, and the housing density is higher in the southern part of the community. Residences are located on lots around an acre or smaller. The houses have roofs that have high fire resistance and mixed combustible/non-combustible siding. Some of the year round and non year round residents have completed defensible space. However, there are many that still lack any mitigation work. RVs in the area are parked near large amounts of fuels. Addressing is mostly consistent with reflective plastic numbering, but many of the signs have been broken and are no longer decipherable. There are ways in and out of the community, but there are multiple dead ends that are not marked and may be confusing in the event of a wildfire. Via del Rey is an important road for the west side of the Village. It is long and there are many homes that are located within close proximity. Roads are gravel, but are between 20-24 feet wide, there are adequate turnarounds, and they are well maintained. Street signs are made out of wood and are not reflective. Water is available from sparse hydrants.

Surface fire is most likely going to occur throughout the community under moderate weather conditions. There are a few areas where individual tree torching may be seen along Peralta Drive. Expected flame lengths are less than four feet. Increased tree torching, flame lengths around eight feet are expected given extreme weather. Rates of spread will be faster in the steep, south facing drainages. Preheating of upslope fuels and flying embers could further fire spread up hill. Pockets of fuels could carry fire uphill and impinge upon the roads and limit visibility along evacuation routes.

- Roadside thinning along potential evacuation routes.
- Ensure dead end roads are marked as such.
- Adequate defensible space is recommended for all homes.

- Simply mowing or weed whacking for 50 feet around homes and structures, and cleaning leaf and needle litter from roofs and gutters and away from foundations, will profoundly increase structure survivability.

- Discourage the use of combustible materials for the construction of projections below roof line such as decks.
- Open areas below decks and projections should be enclosed or screened to prevent the ingress of embers and kept clean of flammable materials, especially where such openings are located on slopes above fuels. Use fine mesh metal screen (1/4" or less) to cover eaves, roof, and foundation vents.

- Discourage the planting of flammable ornamental vegetation within 30 feet of homes.
- Replace plastic address markers, using reflective, non-combustible materials. A good guideline for this practice is to place the markers five feet above ground level on the right side of the driveway.

- Remove wood piles and any flammable yard clutter to at least 30 feet from structures and propane tanks. Wood piles should be located uphill or even with homes; never downhill.

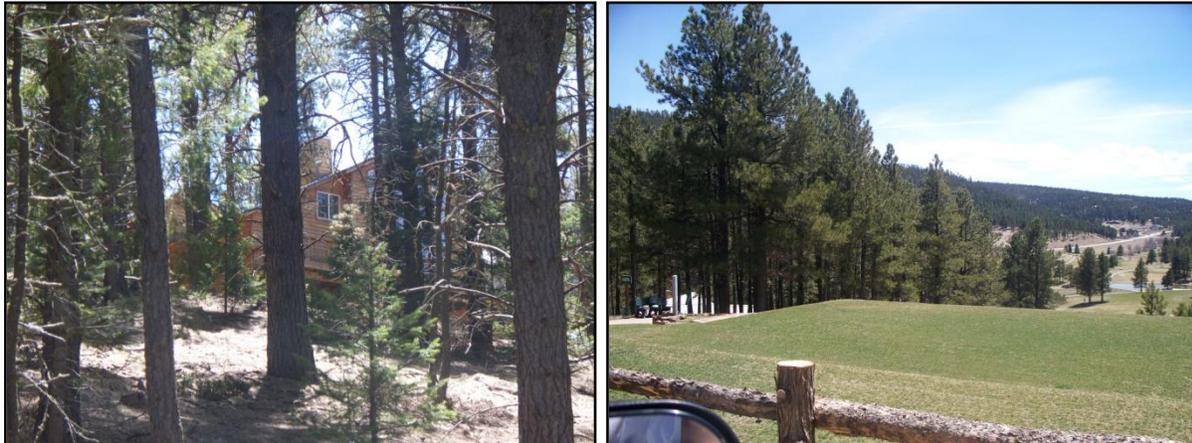
10. *Country Club* – Hazard Rating Moderate

The area encompassed by the Country Club community is diverse in terms of the types of homes and fuels. The lots sizes are less than an acre, and the house construction is consistent, including high fire resistant metal roofs and mixed combustible siding and decks. There are some houses that back to the golf course, which acts as a fuelbreak. The community also includes the area known as the 'Cabin Shares', which provides for higher density, multi-family housing. There are a fair number of homes that are built midslope. Residences around the lake and near the highway have good defensible space. Many of the homes that are located to the west are lacking good defensible space. The addressing is poor throughout, and it is often difficult to see the addresses because they do not have reflective signs or there is no addressing present. A large percentage of the population does not live in the community year-round. Unlike many communities in Angel Fire, there are a large number of paved roads within Country Club. Well maintained gravel roads also exist to provide access to the houses further up the slope, like Agua Fria Drive and Santo Domingo Road. There are multiple routes for ingress/egress if a fire were to occur. Road signs are not reflective and made out of wood. The greatest risk to this community stems from its close proximity to Mountain View Boulevard. Water supply is from hydrants located throughout.

- Remove wood piles and any flammable yard clutter to at least 30 feet from structures and propane tanks. Wood piles should be located uphill or even with homes; never downhill.

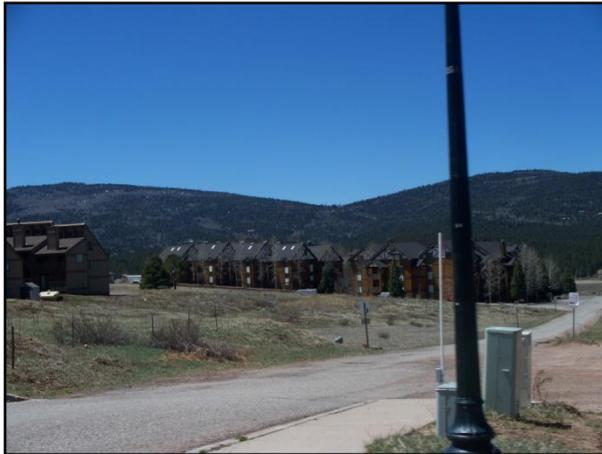
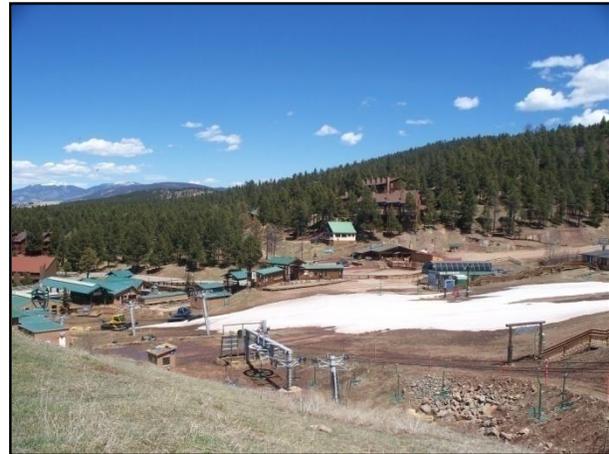
11. *The Chalet* – Hazard Rating Moderate

This area of the Angel Fire Village is different from many of the other communities. The Chalet is the area that is at the base of the ski area, has much higher housing densities, and includes many condominiums and businesses. As with the houses, the condos typically have metal roofs and combustible siding. All of the utilities are located below ground. The number of people staying in the condominiums is lower during the summer than during the winter ski season. There is defensible space for many of the buildings, just based on the land cleared to build and the urban nature of the area. The roads are paved, and road signage is good. Road widths provide for fire apparatus access, as well as adequate turnarounds. There are hydrants located along the main roads and the community is extremely close to the fire department.

- Remove wood piles and any flammable yard clutter to at least 30 feet from structures and propane tanks. Wood piles should be located uphill or even with homes; never downhill.

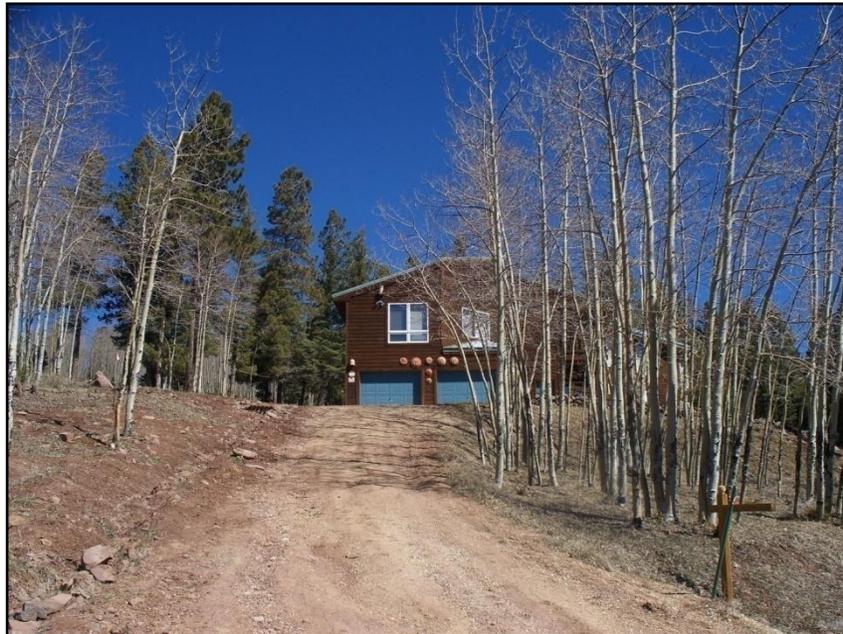
12. Valley of the Utes – Hazard Rating Moderate

The housing density in this community is low. The lot sizes are larger than an acre and there are many vacant lots interspersed between developed lots. The homes have metal roofs, and mixture of combustible and non-combustible siding and decks. Defensible space has been completed for a few homes, but others lack defensible space. Home addressing is inconsistent. Some residences have reflective plastic addressing while others are either missing addresses or are non-reflective. All of the utilities are buried below ground and there is a hydrant system throughout. The road system consists of well maintained gravel roads, with multiple routes for ingress and egress. Road widths are greater than 20 feet and have adequate turnarounds for emergency vehicles. The street signs are metal, but non-reflective.

- Remove wood piles and any flammable yard clutter to at least 30 feet from structures and propane tanks. Wood piles should be located uphill or even with homes; never downhill.

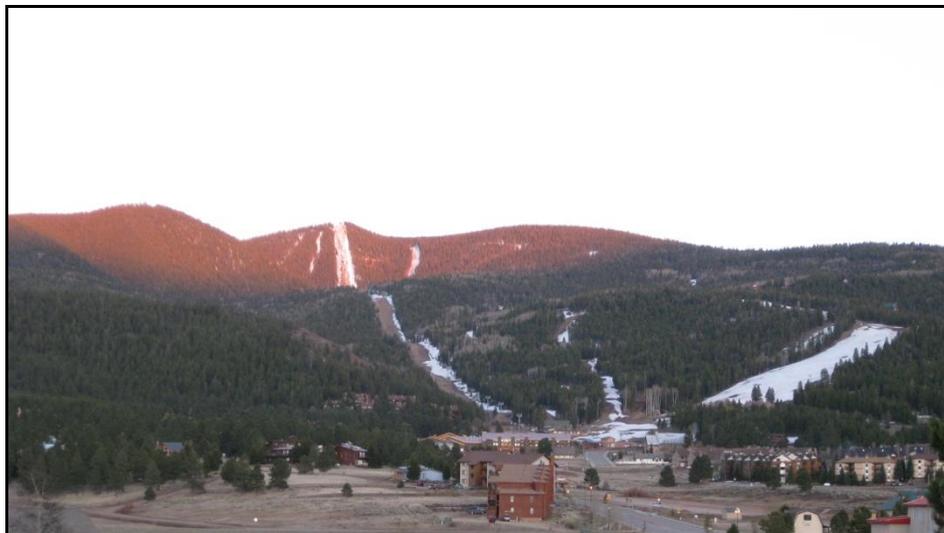
1. Angel Fire Ski Area ASI – *Physical Hazard Rating Moderate*

The Angel Fire Ski Area offers 2,077 feet of vertical terrain available for skiers and snowboarders. There are 74 trails and two terrain parks. Approximately 210 inches of snow fall annually. Over six miles of Nordic skiing is also available. In the summer, the lifts are open for mountain bikers. Several large downhill competitions are scheduled during the summer months.

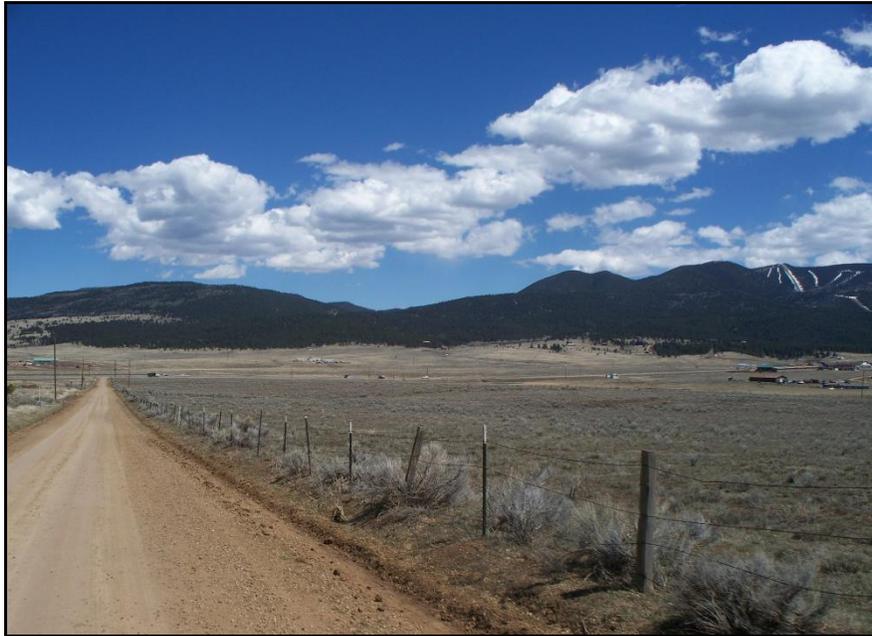
4. Valley Floor ASI - *Physical Hazard Rating Low*

The northern part of the Angel Fire Village is an open valley bottom. Fuels consist of flashy grasses and some small shrubs such as sage. Much of the area is commercial, rather than residential, but there are a few homes in the area. These fuels dry out easily and would carry surface fire quickly. The highway experiences an increased level of traffic, and a single discarded cigarette butt could potentially start a wildfire. Depending on the length of the grass and wind speed, flame lengths could be between four and 12 feet long. Flame lengths above four feet are typically not able to be suppressed by hand crews. It should be noted that the grasslands extend south through the Village along Mountain View Boulevard. The areas along the side of the highway are primarily commercial, and as a result, much of the fuels have been removed between the grass and forested areas, limiting fire spread.
